Building Data Visualization for Diagnostics

By Steven Meyers, Evan Mills, Allan Chen and Laura Demsetz.

ASHRAE Journal June 1996

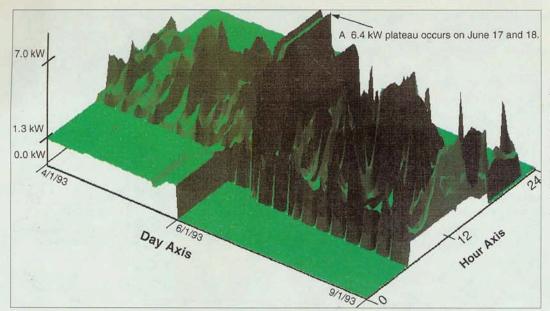
Figure 1: Power from a variable speed supply fan is displayed on a carpet plot. The plot correlates the electricity use of a building supply fan in kilowatts against the time and day of use on the x and y axes, respectively.

When a supply fan and its variable frequency drive perform at less than the optimum level, the fan wastes energy and can damage the equipment. Figure 1, often called a surface or carpet plot, correlates the electricity use of a building supply fan in kilowatts against the day and time of use on the x- and y-axes, respectively. The interval in the plot represents a five-month period from April through September, 1993. Regularly spaced breaks in the data represent weekends. The fan ventilates a 22,000 ft² (2000 m²) office building in Northern California, an area with a hot, dry summertime climate. The plot shows a nighttime offset of 1.3 kW for a period of 4 months beginning in April 1993.

The forest of spikes in the central part of the plot portray the fan's daytime usage pattern. These fluctuations show the fan power profile as the VSD varies the fan's speed.

At a glance, this plot tells the building manager that the EMCS is not shutting down the fan's VFD at night as it should prior to 6/1/93. The 1.3 kW of energy represents an unnecessary cost of perhaps a thousand dollars a year. From the perspective of a building manager, this is a small cost and is passed on to the building's tenants. What cannot be overlooked is the effect of this situation on a piece of capital equipment-the fan's motor. If a motor is not designed to run at low frequencies, it can overheat and burnout if driven too slowly by a VFD. The cost of a replacement motor is a "first cost" incurred by building maintenance, not by the office's

Another interesting feature of this plot are the plateaus occurring on June 17 and 18. In this case, plateaus represent the intervention of a contractor who was performing some type of building maintenance such as duct balancing work, but they could just as well have indicated a critical system malfunction.

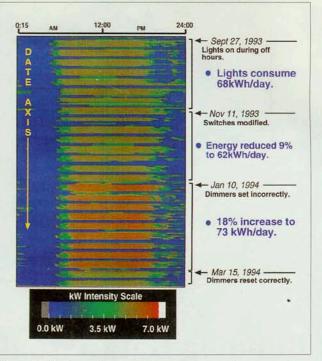
Figure 2: Contour plot shows the various operating stages of occupancy sensors on a bank of T-8 lamps in a California office building.

The electricity usage of a bank of T-8 lamps between September 25, 1993 and March 29, 1994 is depicted in *Figure 2* in a California office building. The lights, outfitted with occupancy sensors, illuminate 10,000 ft² (1000 m²) of the 22,000 ft² (2200 m²) building (Mills 1994a). The plot's dark-blue, regularly spaced horizontal lines represents weekends, when lights were mostly off. The dark vertical band on the left shows the off-hours of lighting energy use during the interval from midnight to about 6 a.m.

The plot reveals two problems with the lighting system's energy performance. The first is evident in the interval be-

tween September 27 and November 11, 1993, during the late evening. The lights are on more than one would expect at this time of night if the occupancy sensors were functioning as intended, switching off lights in the absence of activity in the area. When building managers saw this first anomaly, they investigated and discovered that a security guard making his rounds until midnight each evening was tripping the occupancy sensors, reducing the expected energy savings. On November 11, new switches were installed which automatically turn off the lights but require manual turn on. Energy use went from 68 to 62 kWh (245 to 223 MJ) per day, yielding an additional 9% energy savings.

The data show another problem relating to the dimmable ballasts that were installed as a retrofit energy conservation measure. On January 10, an electrician accidentally reset the ballasts to their maximum settings (from 6 to 7.5 kW). During the following two months—a period in which lighting data visualization was not carried out—, the lighting energy use increase of 18% to 73 kWh (263 MJ) per day went unnoticed. The increase is visible on the diagram as the block of red horizontal stripes in Figure 2. When data for this period were retrospectively analyzed, the problem was identified, and on March 15, the dimmers were reset correctly. Data visualization played a critical role in detecting the problem. The human eye would not detect the small changes in illumination that have such a large effect on power consumption.

Another problem visible in the post-January-10 interval is a second rise in consumption during the night hours. This appears to have been caused by the installation of incandescent lamps in a number of previously unlamped sockets in the building's lobby where no occupancy sensors were present. Another feature here is the slight offset in the first five bands of morning data (upper left) between the < 1 kW and 1 to 5 kW zones. This offset was caused by the switch from daylight saving time to standard time in early November.

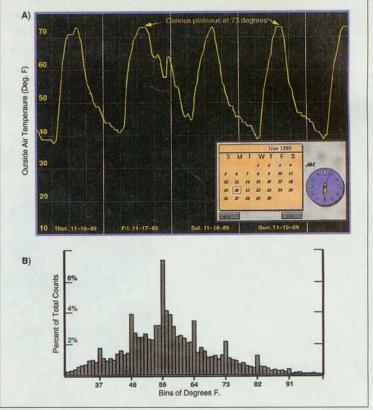
Figure 3: (A) shows time-series plot of the outside air temperature during a one-week period in Northern California. (B) shows histogram of the data which reveals an unsuspected problem with the sensor.

Faulty Outside Air Temperature Sensor: Faulty sensors are common in buildings and have significant implications for energy efficiency. Consider the data collected from an outside air temperature sensor during the entire year of 1992 in San Ramon, California. Most EMCSs use such a sensor to control the chiller lock-out or determine the effectiveness of economizers and evaporative coolers. At a first glance, a common timeseries plot of the outside air temperature (*Figure 3a*) suggests reasonable behavior of the variable. However, a careful observer would notice the curious plateaus indicated on the Figure. Visualizing the frequency at which a given temperature interval occurred as a histogram (*Figure 3b*) reveals an unsuspected problem with the sensor. A smooth Gaussian-type distribution around the city's mean temperature would be characteristic. The data displayed on the histogram suggest the implausible circumstance that a tem-

perature of 64°F (17.7°C) occurred more than twice as often as a temperature of 63°F (17.2°C) and 65°F (18.3°C). This sensor failed by "sticking" every 9°F (5°C).

case, the problem would be visualized by plotting daily profiles of outside air temperature with another point corresponding to the condenser's status. If a sensor is located too close to the roof of a building or not properly shielded, false high temperature readings may allow the EMCS to turn on energy-intensive mechanical cooling before it is really necessary. Visualizing daily, un-averaged temperature profiles such as the time-series in *Figure 3a* can help detect this error.

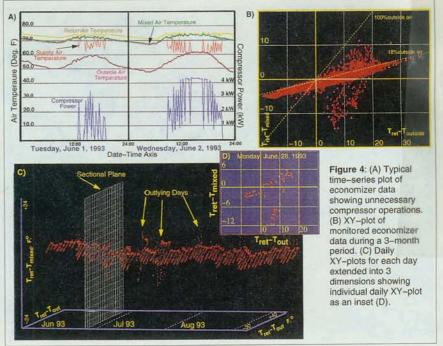
Figure 4a shows a common profile of the mixed air, supply air, and outside air temperatures, as well as the compressor's power during a two-day period from June 1-2, 1993. Viewing the compressor power (or even compressor status) with this profile suggests that the economizer is not

functioning correctly because the compressor is running even when the outside air is cooler than the supply air and latent cooling loads are not significant.

Although scrolling through daily profiles provides detailed information about the economizer, it does not provide a picture of the economizer's overall performance. An XY-plot of the difference between the *return* air temperature and the outside air temperature ($T_{\rm ret}$ - $T_{\rm outside}$) versus the difference between the return air temperature and the mixed air temperature ($T_{\rm ret}$ - $T_{\rm mixed}$) summarizes three months of data relating to the economizer (*Figure 4b*). This Figure displays data collected between May 29 through September 9, 1993 at 15-minute intervals. The dotted line represents an outside

air fraction (OAF) of 1 where 100% outside air supplies the building. The data in this display suggest three possible operating regions:

- 1. Damper Stuck: Most of the data are clustered around an OAF of 18% which suggests the damper's position does not vary.
- 2. Correct Operation: Some points are scattered between OAF=100% and OAF=0% suggesting the economizer is in fact varying and operating correctly.
- 3. Mysterious Operation: Points in the lower right quadrant suggest the anomaly that $T_{mixed} > T_{ret} > T_{outSide}$. This would be impossible without the addition of some heat.

Although the density of data in *Figure 4b* suggests that the economizer is often stuck at an OAF of 18%, some information is lost when data from all of the days are displayed on one 2-dimensional graph because times and dates cannot be correlated with particular data points. The conditions and chronology corresponding to each of the three regions cannot be known. Since regions of the data display become saturated with data points, the relative time spent operating in each of the three regions cannot be clearly determined. Extending this display into three dimensions by creating an XY-plot for each day (*Figure 4c*) shows that there are only about five days that deviate from region 1 described above.

While visualizing a 3D display as in Figure 4c, a sectional plane can be passed or even animated through any day. Data from this single day can be displayed simultaneously as an in-

set XY plot (Figure 4d). Animating this 2D XY-plot through time adds an additional dimension to the data and can indicate trends correlated with the time of day or the hours when the building is not occupied. When the sectional plan was passed through the entire 3D display, the XY inset clearly showed collinear data points falling around 18% OAF for all except five days. These five days primarily had mysterious patterns when data points fell in the lower right quadrant (described above as region 3) as shown in Figure 4d. The user can view the dates and times of these anomalies and then display the anomaly differently, for example, in a detailed timeseries plot. The analyst can display other relevant parameters such as compressor power, fan power, or relative humidity and see the exact conditions under which the anomaly occurred. In this case, this analysis showed all of the "mysterious" days corresponded to times when the supply fan was not operating and heat from either the burner, sunlight, or compressor heated the mixed air. This discovery indicated that the economizer was in fact never operating correctly. Visualizing the correct variables with the correct displays quickly allowed analysts to answer a variety of diagnostic questions as they surfaced.

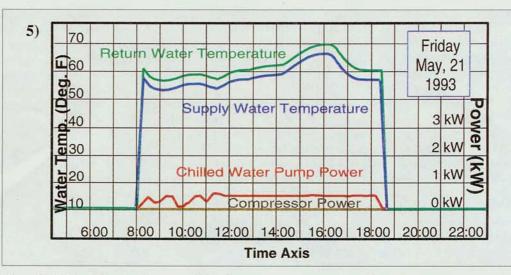
actual outside tem- Figure 5: Daily profile of split-system chiller shows pumps are operating without the compressors.

A first step in performing relational checks is reviewing the mechanical drawings or control diagrams of the building to determine how the systems were intended to work. For example, in a simple water-air cooling system, the design intent would be that the chilled-water pump not be running if the compressors are not running. Actually, in some systems, the pump should be running slightly more than the compressors. After the compressors shut-down, the water and the refrigerant are still cool enough to absorb some heating load. Circulating the water throught the chiller and air-handler coils takes advantage of this residing "coolth." However, the daily profile in Figure 5 shows that on May 21, 1993, the compressor never turned on, but the pump was running almost all day at its maximum 0.6 kW. Scrolling through months of data, we noticed several other days similar to this one. In addition to wasting the energy to run this pump, unnecessary operation prematurely wears the pump. The building's mechanical contractors were notified and corrected the error in the EMCS program that caused this malfunction.

Collecting the data necessary to perform relational checks is relatively easy. Most EMCSs monitor each component's "status" and can therefore indicate when it is running or the total hours of operation. However, such status indicators cannot quantify parameters such as speed, current, or energy consumption. Some relational checks can be performed with run-time data alone. For example, in the system described above, the pump and the compressors should be running almost the same amount of time. If one runs significantly more often than the other, there is likely to be a problem. Monitoring run-time is generally one of the least expensive measurements because only a single scalar value (time of operation) is recorded as opposed to an array of values necessary to express a time series. We have even seen pocket temperature sensors taped to a motor to determine when it was running by the increase in temperature!

Returning to Figure 5, we cannot ignore the 3.5 °F (1.9°C) error in the calibration of the supply and return water temperatures. Looking again at the design documents, it is clear that if the compressors are not running the refrigerant loop is not moving and these sensors should read the same temperature. ASHRAE recommends that delta-temperature measurements in a water loop be accurate within 0.5°F (.3°C) (ASHRAE Standard 114-1986). These results were presented to the building's mechanical contractor who recalibrated the sensors. The energy effects from this miscalibration are subtle. If the sensors were connected to an EMCS, then the particular HVAC components controlled by the chilled water temperature could have been triggered before they were necessary. Modeling the actual and designed performance in a building simulation package would be the most reliable method of determining these energy effects. However, the sensors in this case study were installed to evaluate the energy consumption of this chiller, which was installed as a retrofit energy conservation measure. If we assume a full-load operating delta-temperature of 10°F (5.6°C) in the water loop, the error in calculating the COP of this chiller will be at least 35% (this is only the error caused by the temperature sensors and does not even consider that when calculating the COP of an air-water cooling system, it is also necessary to measure the water flow, which generally has an error of 5-10%) and therefore unreliable. Visualizing monitored data from these systems helped to identify this measurement problem.
